Climate Change and Immovable Cultural Heritage in Kenya: Impact and Response Strategies

Angelah Chemeli, Joseph M. Njoroge, and Peace B. Agufana

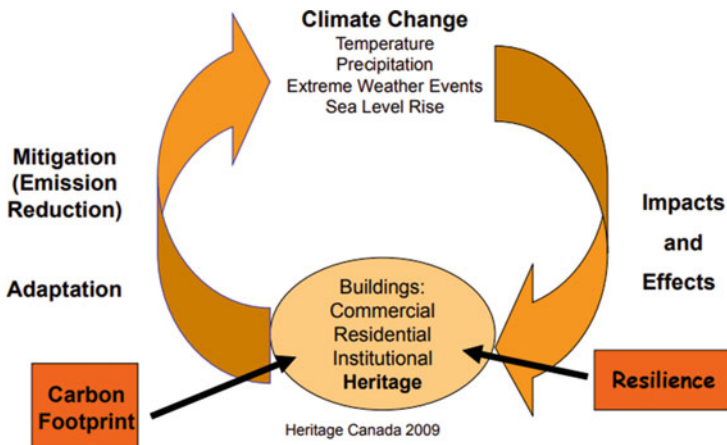
Fig. 1 Climate change and heritage (Source: Chiotti 2009, P. 5)

On the other hand, Longfield and Macklin (1999) argue that the inorganic materials suffer from erosion and contamination when salt content and water together with the materials undergo chemical reaction due to different varying conditions they are exposed to. Although most of these cultural heritages are made of stone which is assumed to be a strong material, it is not always true (Hambrecht and Rockman 2017). Goudie (2016) reveals the worrying vulnerability of stones under the influence of moisture and vegetation. Rock types such as limestone and soapstone are soft rocks; hence they get eroded more quickly (Geological Survey of Finland 2006). Fig. 1 demonstrates the processes.

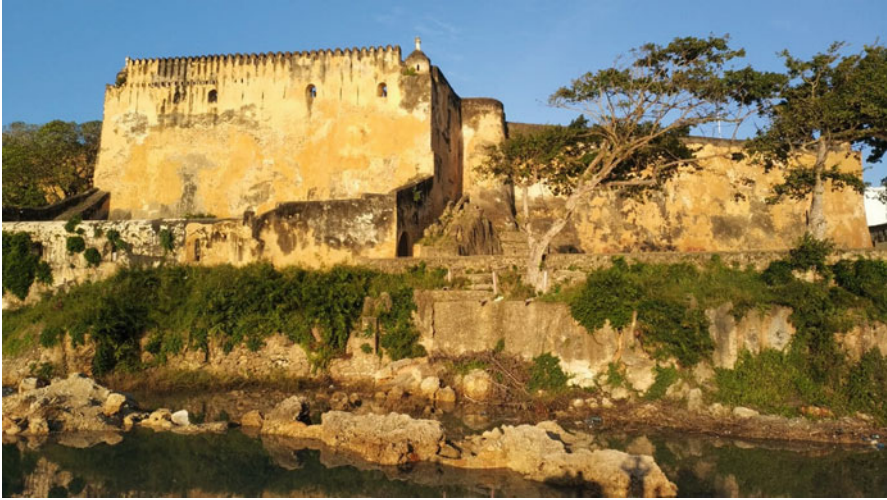
Fig. 2 Fort Jesus (UNESCO heritage) (Photo taken by the authors 2019)

archaeological findings, and the old law court gallery hosts temporary exhibitions. The fort overlooking the entrance of Mombasa old port represents the sixteenth-century Portuguese military architecture. The base of Fort Jesus is being steadily eroded by the rising sea tides (Fig. 2).

The Fort Jesus case shows that the heritage has been affected by a number of natural forces. The UNESCO world heritage site exhibited the following forms of deterioration. The walls of the fort exhibited cracks, peeling-off of plaster and paints, and splitting of some parts which are attributed to expansion and contraction of walls due to high temperatures, direct sunlight, high humidity, and direct rainfall. Presence of plant growth such as algae, moss, and lichens were visible on the walls and wooden parts. High humidity, warm temperatures, and heavy rainfall provide conducive conditions for the growth of plants and insect infestation on the wooden parts. The basement of the fort has been corroded with sea level rise and increase in acid levels in the water. The roofs and metallic parts exhibited rust on their surfaces which are caused by salt contents in the coastal winds and acidic rainfall.

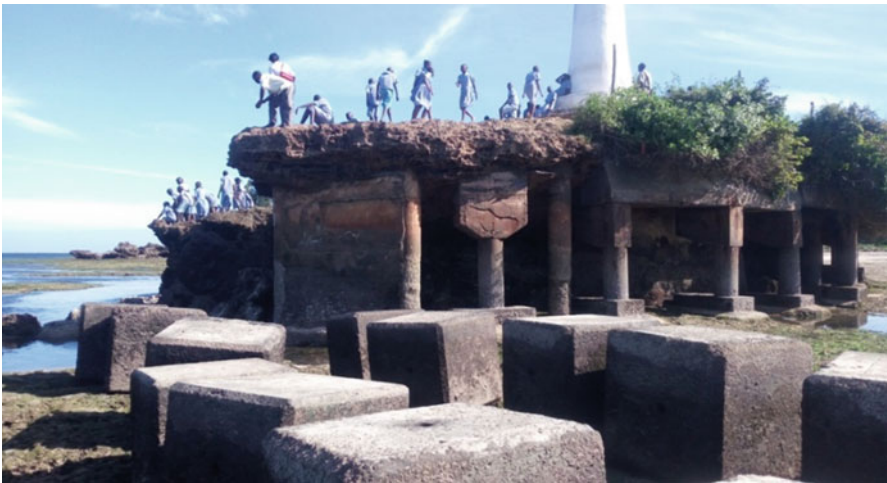
The Vasco da Gama Pillar, being one of the main attractions in the coast region of Kenya, has recently been highlighted to be in danger of being lost due to climate change. The pillar built on the coral rocks on the ocean shores in Malindi is under threat from rising sea levels. Increase in sea level and increase in acidity levels cause coastal flooding, coastal erosion, and storm surges. The basement pillars enforced to support the Vasco da Gama Pillar have been eroded by sea water. Destabilization of the foundation has caused the development of cracks that are visible on the pillar. Plants have also grown on the basement as a result of conducive conditions of high humidity and warm temperatures. The lime on the pillar is still faintly visible. Direct rainfall on the pillar washed away the lime (Fig. 3).

Fig. 3 Vasco da Gama Pillar in Kilifi

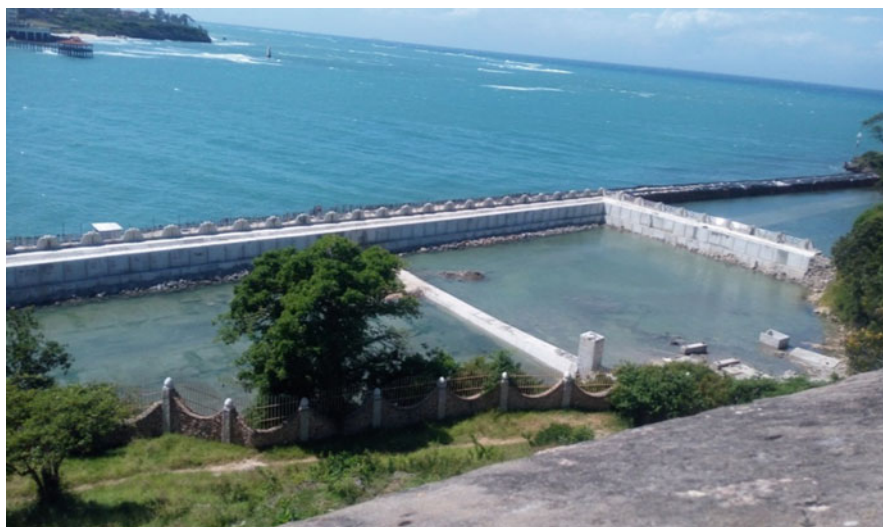
Fig. 4 Construction of sea wall at Fort Jesus (Authors 2019)

Fort Jesus is the only immovable cultural heritage that has begun the construction of a sea wall apart from Vasco da Gama Pillar and Jumba la Mtwana which have the same plans in place. These three sites are located along the seashore, hence are affected by sea level rise, coastal erosion, and silts deposits. Due to erosion of the fort basement, two hectares of land was reclaimed from the sea where the wall was constructed. The wall is yet to be completed. Fort Jesus being a world heritage, it took the efforts of the local government, national government, UNESCO, and other European sponsors to have the wall constructed so as to save the heritage. The wall will act as a barrier to protect the fort from not being in direct contact with the ocean water; thus cases of erosion will be minimized. Materials used in the construction are marine friendly which include marine cement and iron bars; hence the strategy is believed to be very effective. The sea barrier will counteract water waves, silts, and water speed that would cause damage to the fort (Fig. 4).

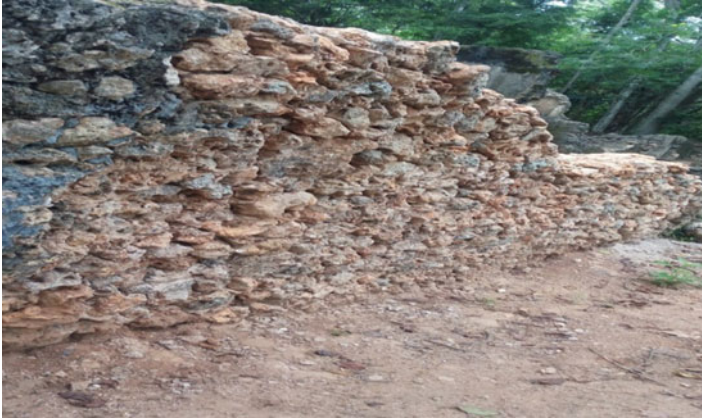
Fig. 5 Repaired wall at Gede Ruins (Authors 2019)

In Mnarani and Gede Ruins, fallen parts of the important sections have been repaired. Ruins are being repaired with coral rocks and lime. Repairs are done on frequent basis and are only repaired to their original position (Fig. 5).

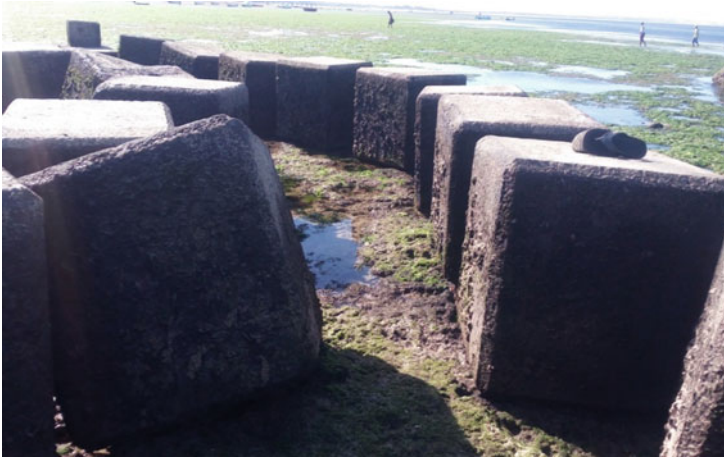
Fig. 6 Blocks placed at Vasco da Gama Pillar (Authors 2019)

Massive blocks have been placed near Vasco da Gama Pillar to counteract the effects of waves. This is one of the strategies in place to protect the pillar from coastal erosion that has seen the loose of the basement (Fig. 6).
